R 393

DEEP-OCEAN BIODETERIORATION
OF MATERIALS — PART II. SIX
MONTHS AT 2,340 FEET

August 1965

U. S. NAVAL CIVIL ENGINEERING LABORATORY
Port Hueneme, California

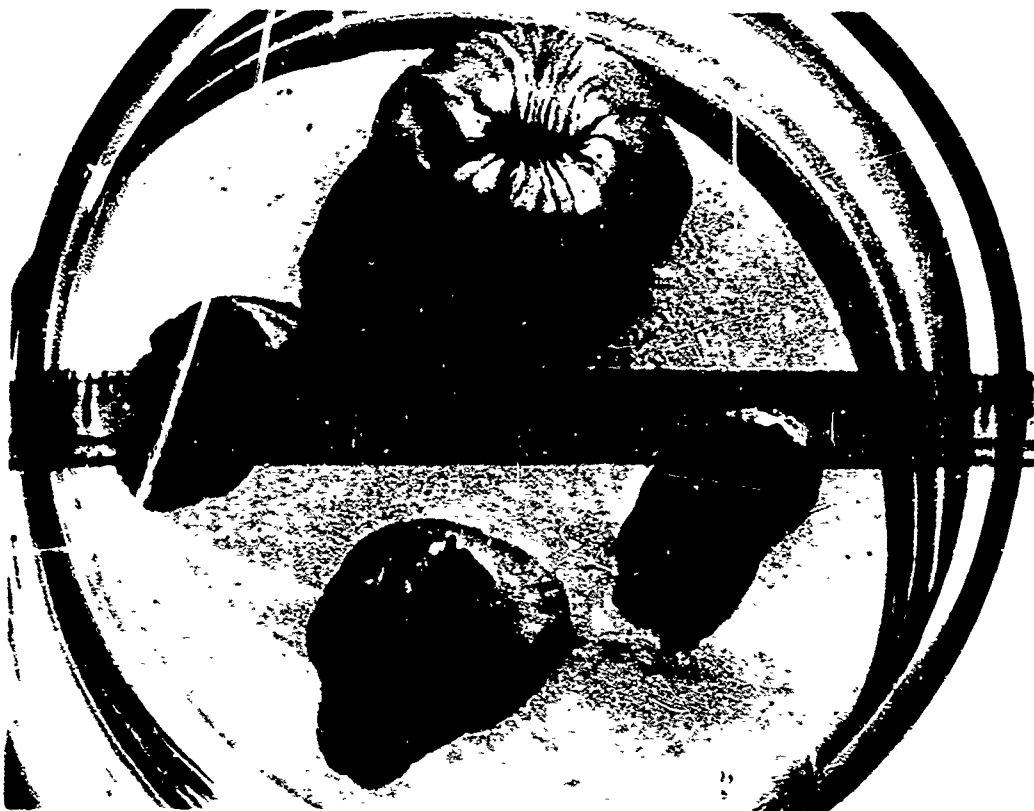
A large number of pink sea anemones, up to 3 inches in diameter at the base, were found securely attached over the entire 6,000-foot length of polyethylene-jacketed 1/2-inch-diameter wire rope (Figures B-3 and B-4). The jacketed wire rope was attached to the STU frame and stretched across the ocean floor to serve as an alternate method of retrieving the STU by means of grappling.

Figure B-4. Close-up view of deep-sea anemones.

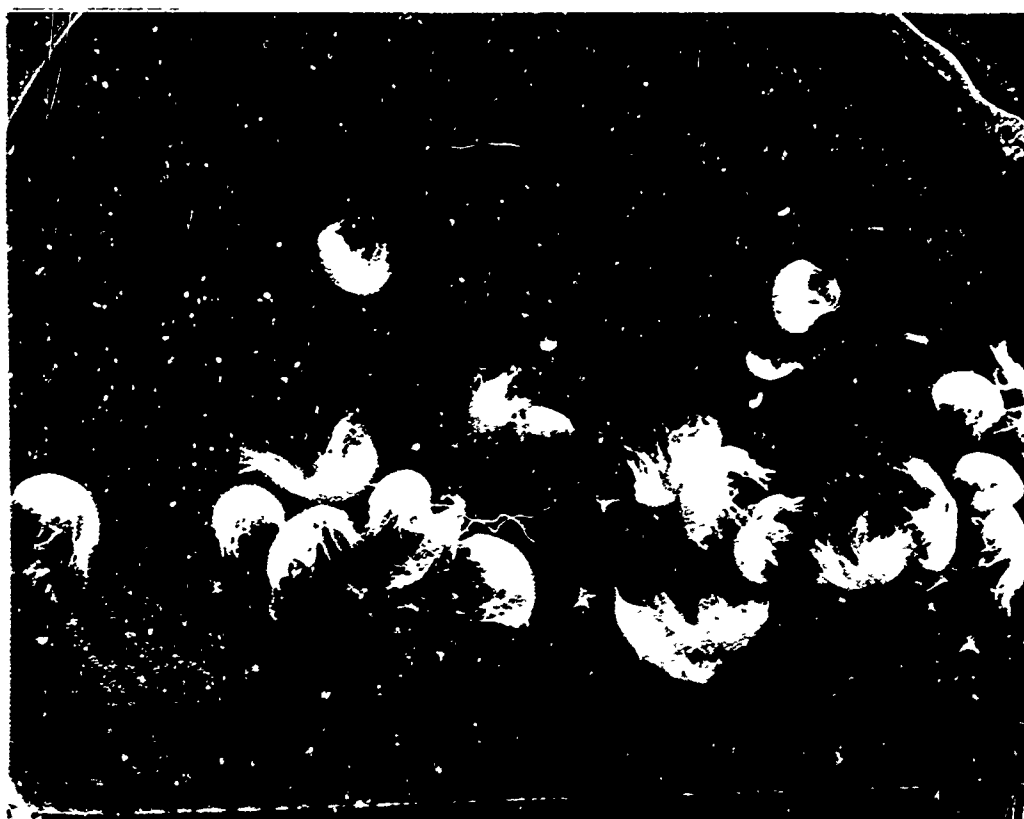
There were several hundred amphipods (Figure B-7) about 3/8 inch long swarming over the materials on the bio-rack. It is possible that several thousand other amphipods may have been washed off during recovery of the STU. In addition to the amphipods, about two dozen small crabs were also found crawling over the materials on the bio-rack (Figure B-8). One was found wedged in between metal test specimens.

Figure B-7. Amphipods found on STU test specimens.

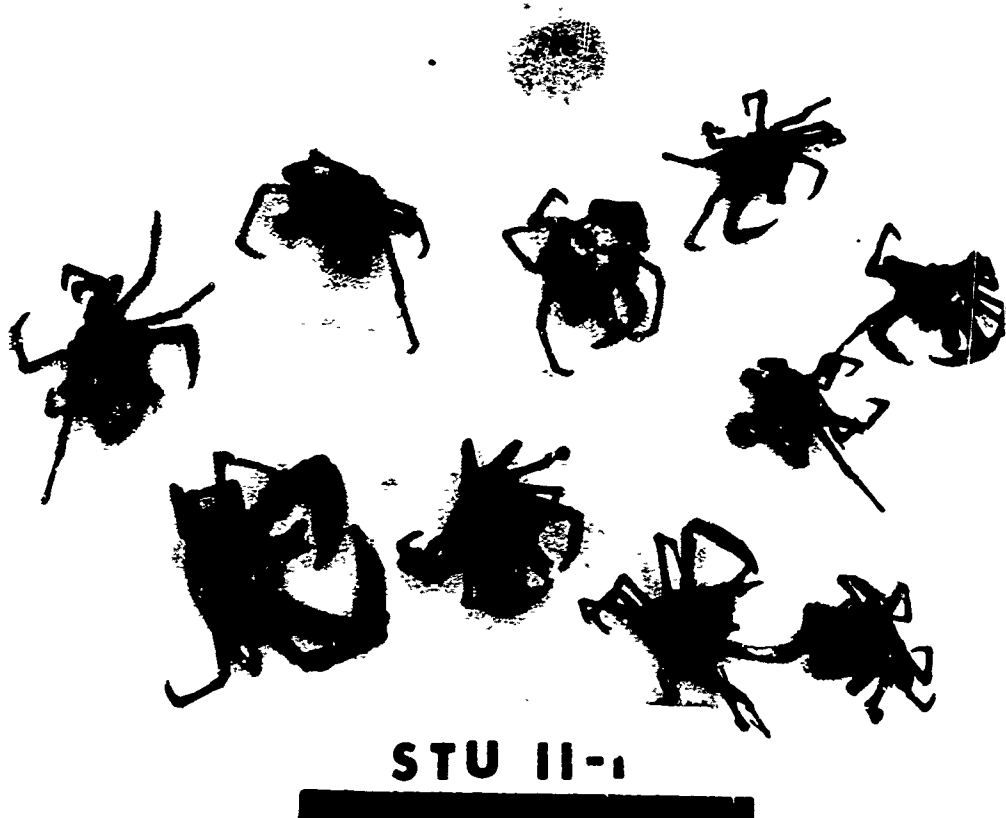
Figure B-8. Deep-sea crabs found crawling over STU test specimens.

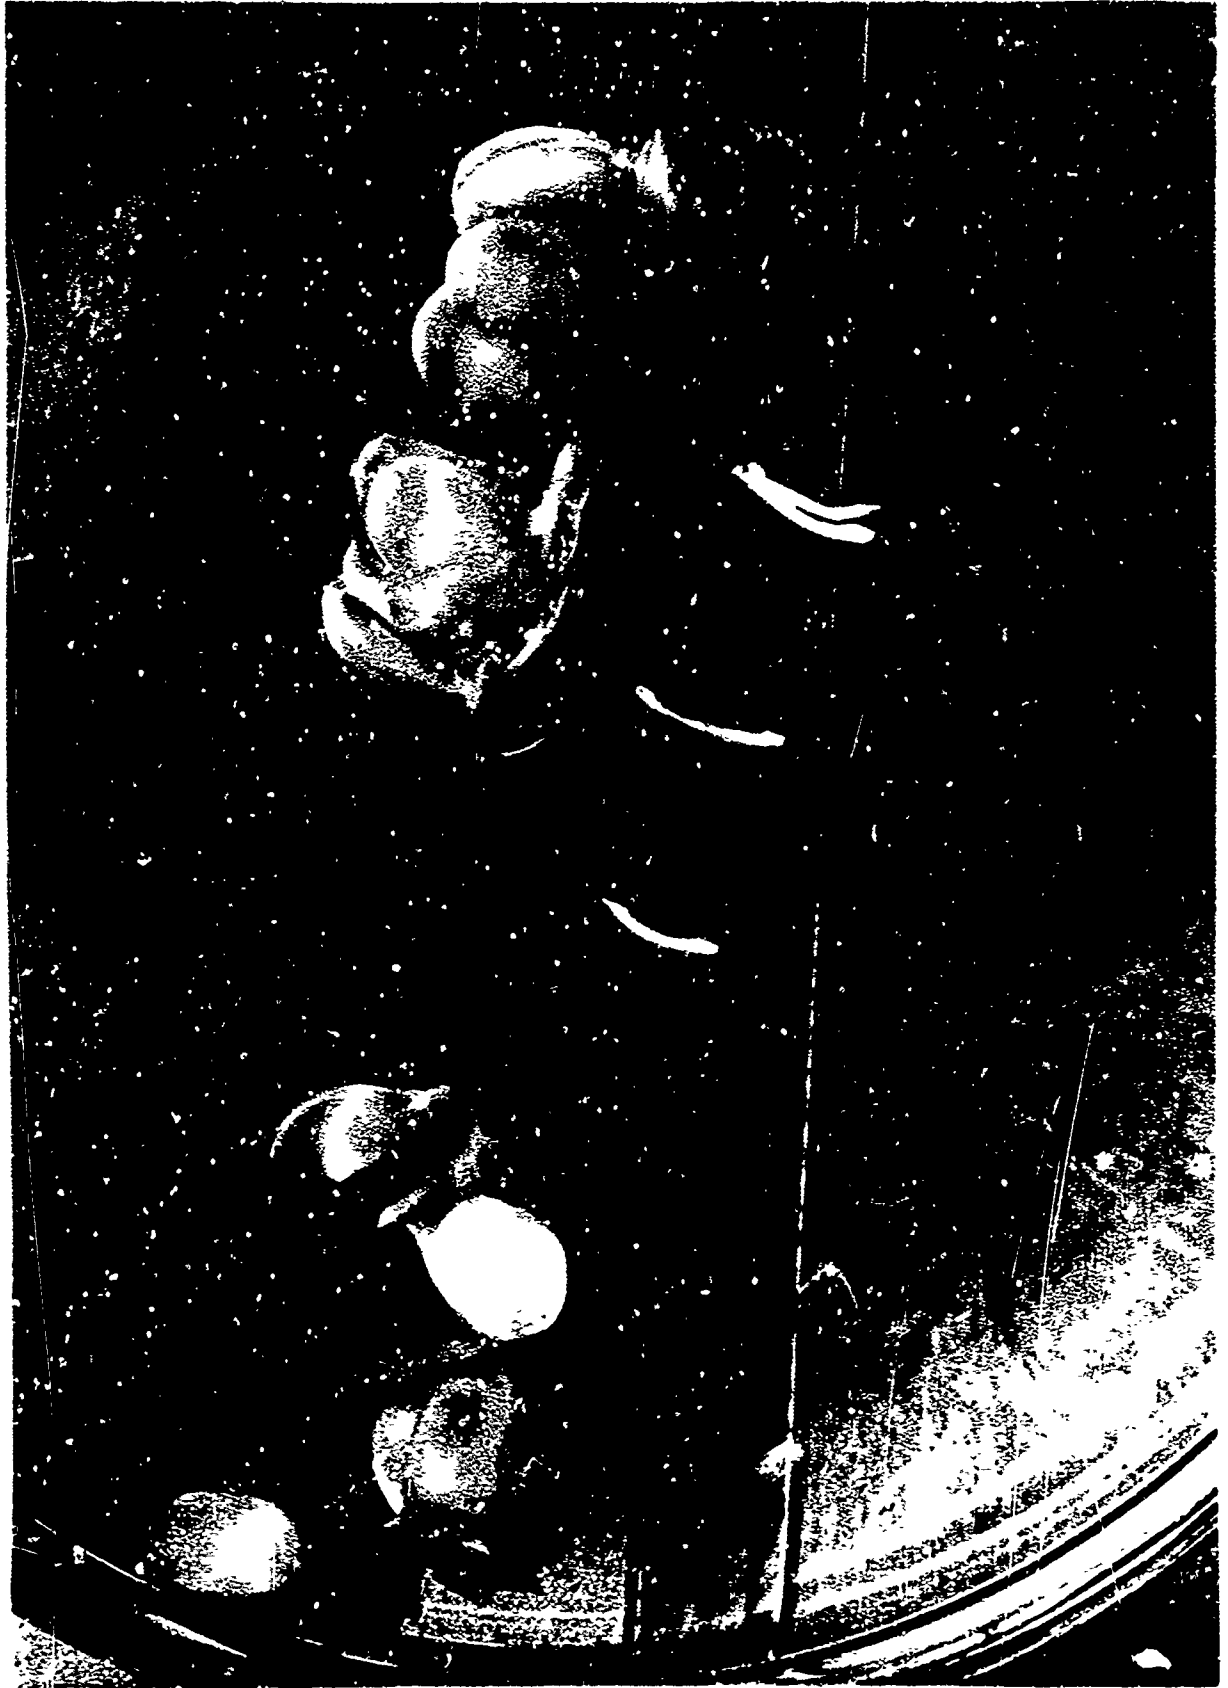
There were no signs of typical attachment organisms such as bryozoa, barnacles, or tube worms on any of the metal test specimens. Portions of hydroid colony (branches) were caught on the surface of most of the metal specimens, and there was a cluster of grapelike yellow growth (Figure B-9) securely attached to the surface of a metal panel.

Figure B-9. A colony of fouling growth found attached to the surface of a metal test panel.

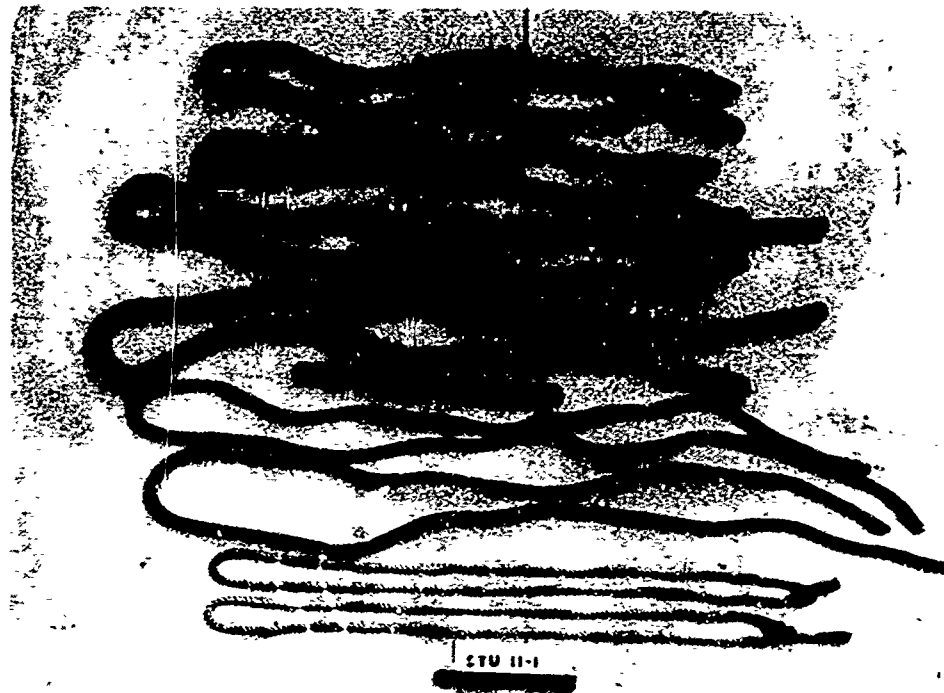
A heavy growth of slime bacteria was present on the surface of nylon, polypropylene, cotton, and Manila ropes (Figure B-12). The fibers of cotton rope were decayed considerably by bacterial action. The cotton fibers were easily pulled apart by tweezers or one's fingers. Because of the damaged fibers, considerable difficulty was experienced attempting to place a splice at each end of the cotton rope for a breaking-strength test (Figure B-13). Only a few marine borers were found on the cotton, resulting in little damage to the fibers by borers.

Figure B-12. Cotton, Manila, polypropylene, and nylon rope specimens after recovery.

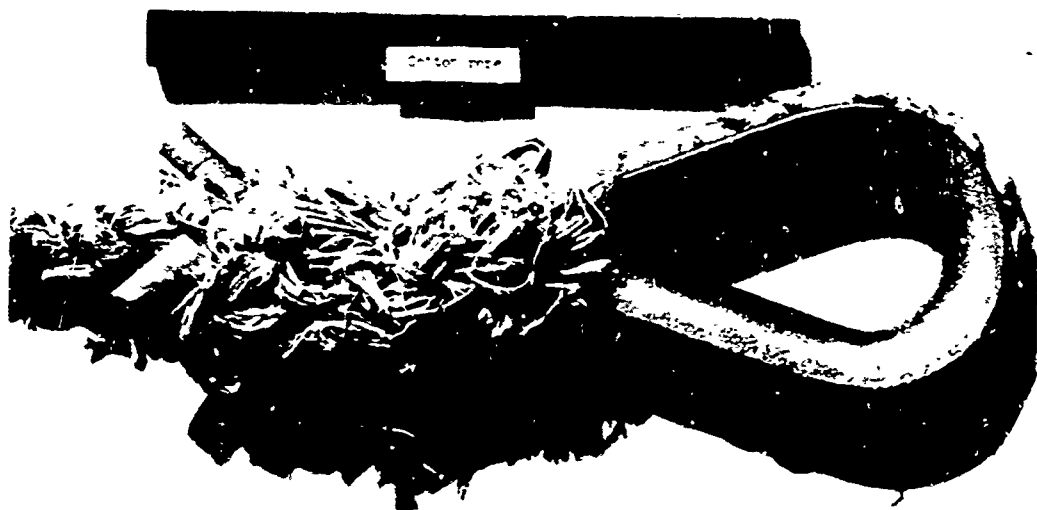
Figure B-13. Fibers of cotton rope decayed by microorganisms.

Because of severe biological deterioration of untreated wood panels (including redwood), jute fiber materials, and cotton and Manila ropes, the use of these materials for deep-ocean applications is not recommended. Electrical cables covered with silicone rubber insulation is not recommended for use on the sea floor in the vicinity of Test Site II, where large deep-sea crabs exist and presumably attack this material.

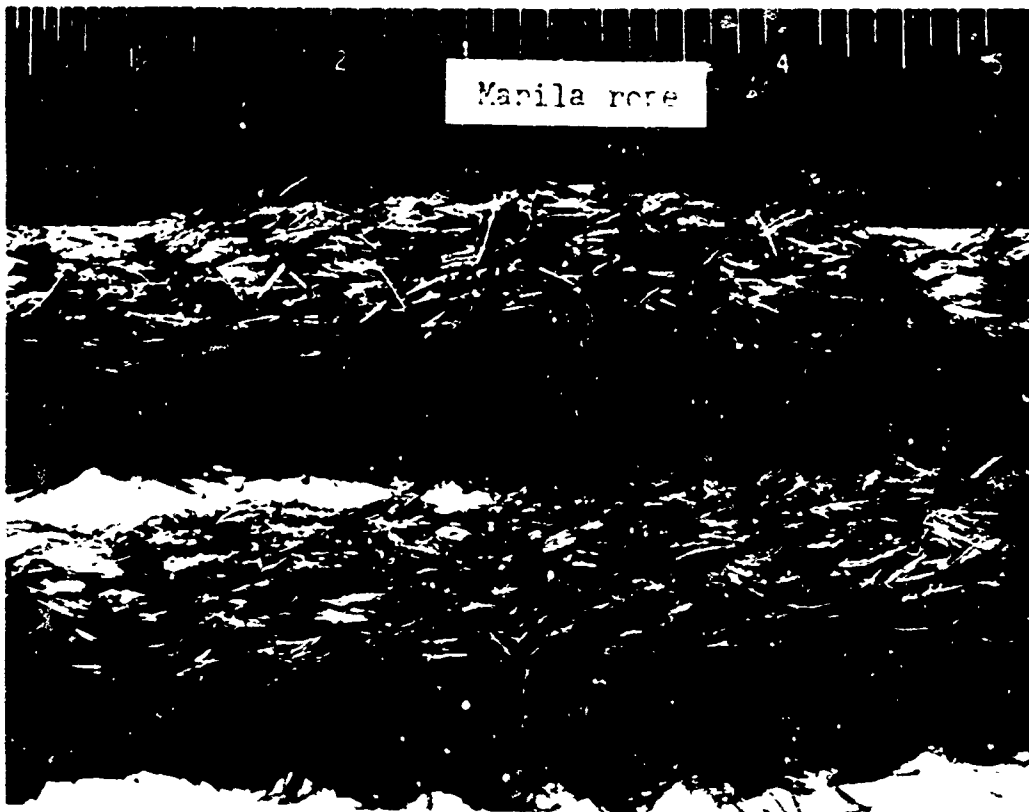
Manila rope specimens were severely damaged by marine borers. The fibers were severed completely by the boring action of small borers. The 1/2-inch-diameter Manila rope was so heavily infested with borers deep inside the rope that it was impossible to count the numbers present. It was estimated that there were several hundred per lineal inch of the entire length of two 5-foot rope specimens (Figure B-14). In addition to the borers, slime bacteria were responsible for the decay of fiber materials.

A splice could not be placed on the Manila rope specimen for a breaking-strength test because of the deteriorated condition of the rope. However, by examining the damage to the hemp fibers, it was estimated that 75 percent of the tensile strength of the rope was destroyed. The deterioration of fishing nets and ropes made of natural fibers has always been a serious problem. It has been recognized that microorganisms are the primary cause of decay of fibers, resulting in loss of tensile strength. The microorganisms responsible are chiefly cellulose-decomposing bacteria.

Figure B-14. Fibers of Manila rope destroyed by marine borers. Hundreds of borers are visible on the rope.

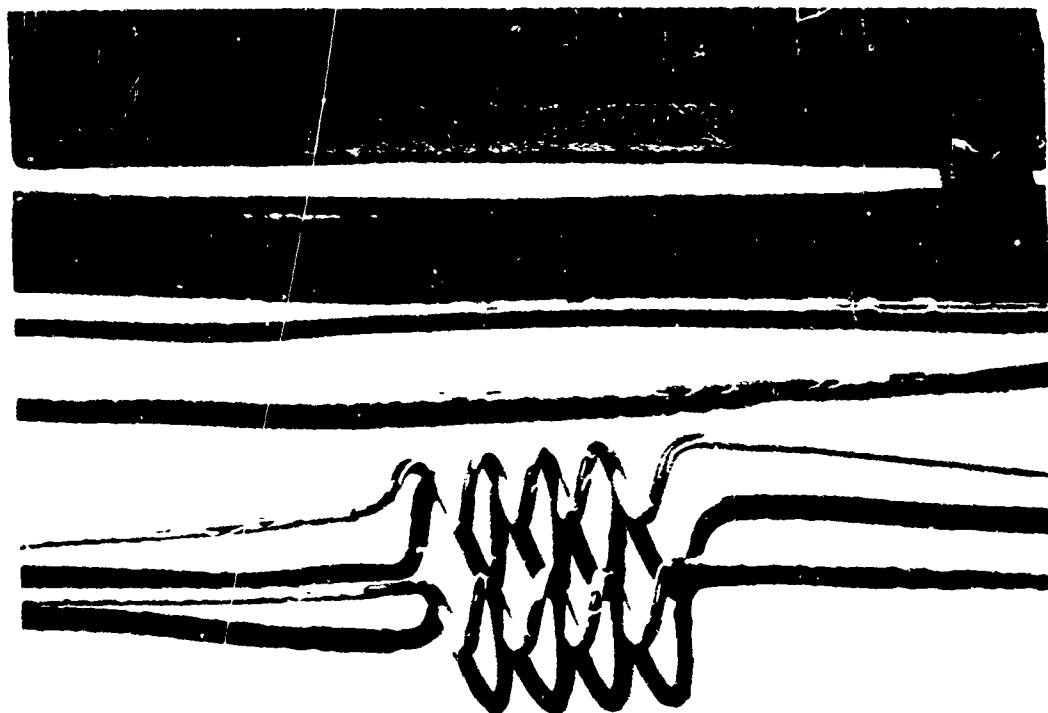
The 1.5-inch-long stressed and nonstressed silicone-rubber-insulated wire specimens exposed next to sediment and another identical set exposed to sea water about 3 feet above the sediment were deteriorated by marine animals. Microorganisms, amphipods, and crabs found on the STU may have been responsible for the destruction. The specimens of silicone rubber insulation exposed near the bottom were heavily damaged, exposing the bare wire to sea water in several areas (Figure B-18).

Of the various insulations of varied thicknesses over single and multiconductor wires, the 1/16-inch-thick silicone rubber insulation exposed over the sediment was severely damaged by nibbling and chewing, presumably by amphipods and crabs. Some areas of the insulating material were completely destroyed, exposing the bare wires to sea water (Figure B-18). The silicone rubber insulation exposed about 3 feet above the sediment was also attacked by marine animals but not as severely as the one exposed near the sediment.

animals were probably responsible for the damage to the silicone rubber insulation at Test Site II. Silicone-rubber-insulated cables exposed on the sediment at Test Site I were not damaged.

Figure B-18. Wire showing through silicone rubber insulation where the material was deteriorated by nibbling of marine organisms.

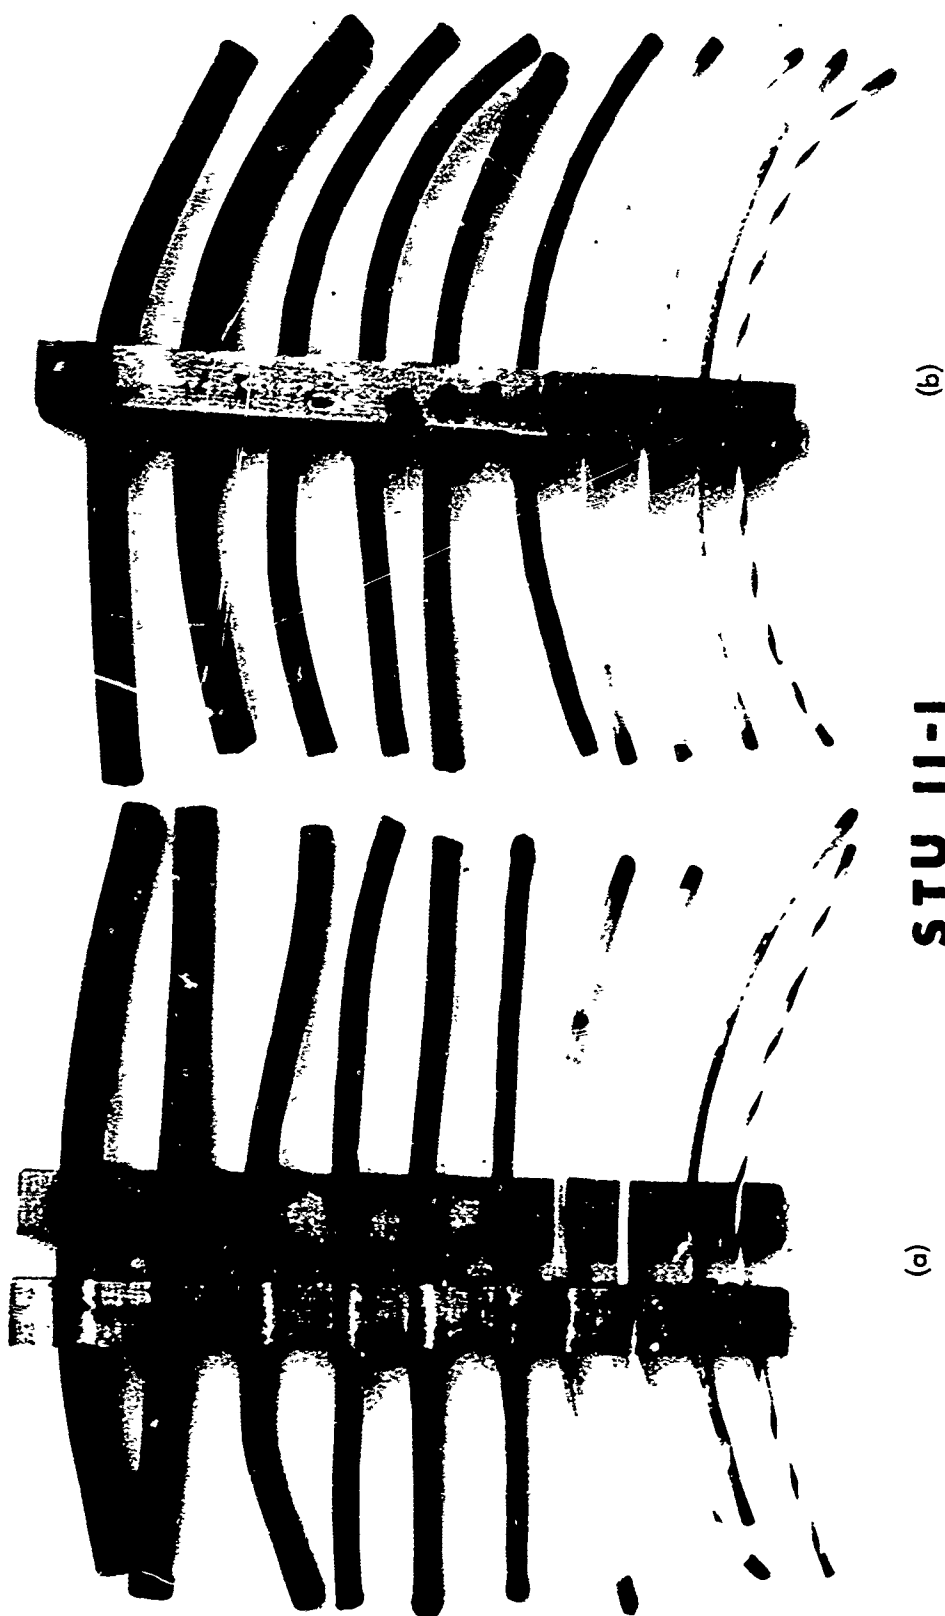
A few borers had penetrated slightly into the silicone rubber (Figure B-19) and nylon insulating materials. The borer holes found on the silicone rubber were exposed to the sea-water environment. The borer holes found on the nylon, however, were exposed in an area underneath the wooden bait piece. The bait piece exposed near the sediment was severely damaged compared to the piece exposed about 3 feet above the sediment (Figure B-20).

Figure B-20. Electrical cable test specimens showing: (a) numerous borer penetrations of wooden bait piece on specimens exposed near the sediment; (b) slight attack on specimens exposed about 3 feet above the sediment.
